Architectural Design Standards

Albemarle Park Local Historic District • Asheville, North Carolina

Produced by the Historic Resources Commission
of Asheville & Buncombe County
in association with
The Albemarle Park ~ Manor Grounds Association, Inc.

Adopted July 8, 2015 and Amended March 11, 2020
© Copyright 2000, 2001, 2013, 2015, 2020. All Rights Reserved

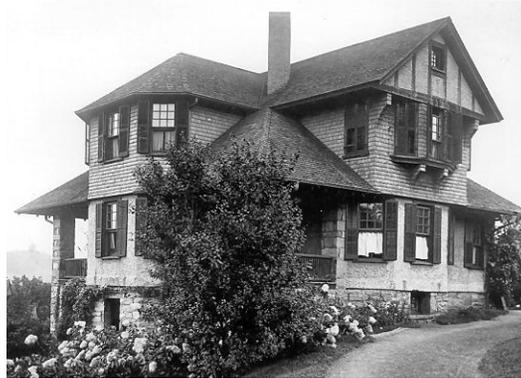
Clematis Cottage possesses many of the design features of this style - half-timbering in the gables, shingles at the 2nd floor, pebbledash stucco at the 1st floor, and a stone foundation.

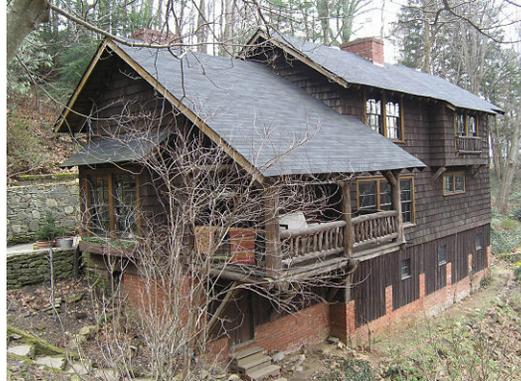
Above: Possum Trot, displaying several of the key elements of the Rustic Shingle Style - dark brown stained shingles, large timbers used for porch supports, and projecting bay windows.

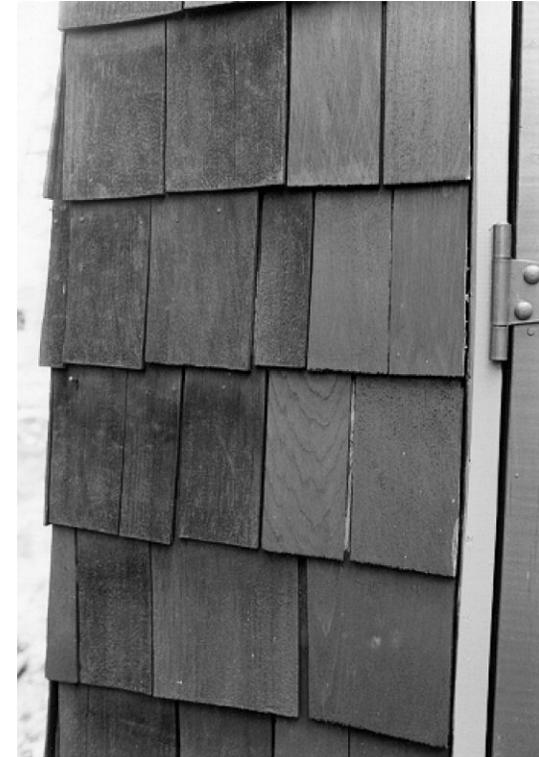
Above: Doing repairs to historic houses requires a nuanced and respectful approach. Replacement shingles on this garage stand out because their texture doesn't match the original. A better approach would have been to use new shingles for the entire rows, possible replacing a much larger section than necessary to mute the visible contrast.

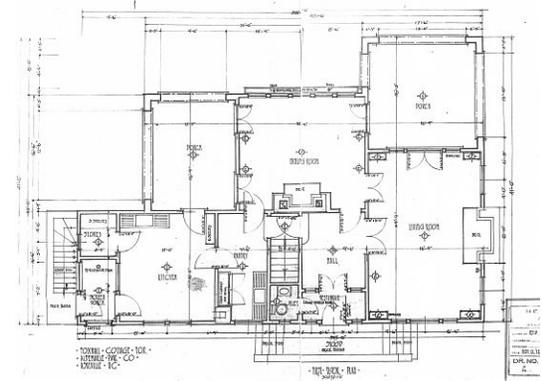
Above: The first floor plan from the blueprints that were at Georgia Tech.

Then, a phone call out of the blue from a historian in Raleigh led to the discovery of the original blueprints for the cottage. It was designed by J. Neel Reid, a prominent Georgia architect, and the firm Hentz & Reid.

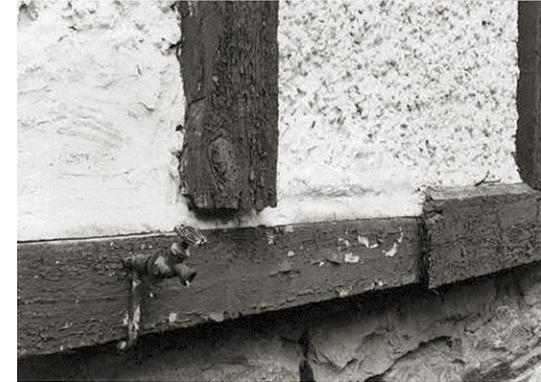
Above: Deteriorated pebbledash/roughcast stucco and a rotten band board were replaced by inappropriate materials - smooth plaster and an undersized board.

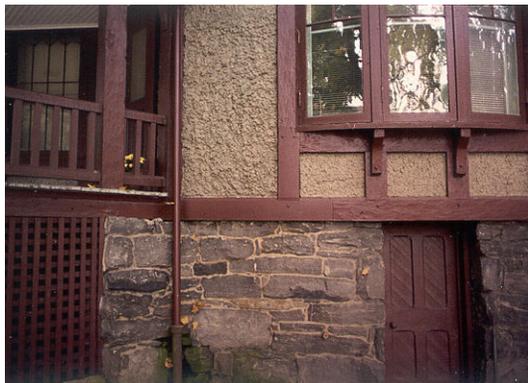
Above: Close up photo of the inappropriate repair described at the left.

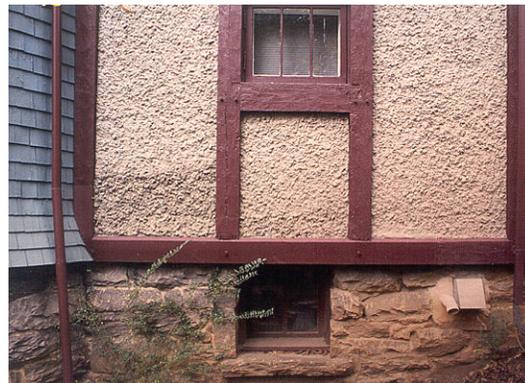
Below: The lap siding was removed and the half-timbering and stucco were repaired to restore the original appearance.

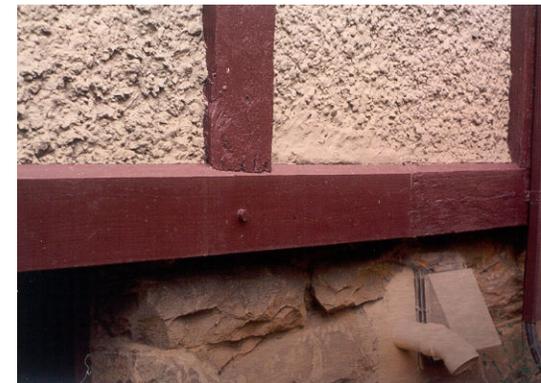
Below: The inappropriate repairs were removed. Stucco which matches the original was applied and a band board milled and beveled to match the existing was installed.

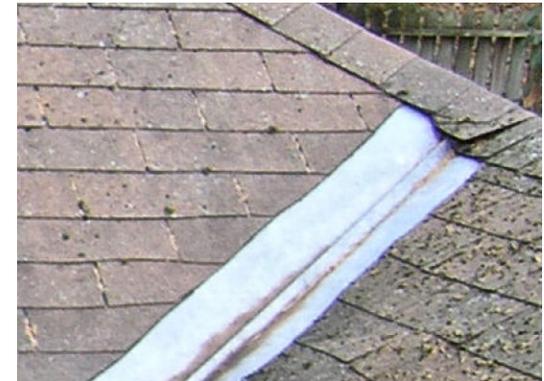
Below: Valleys should be open, with shingles trimmed to a straight edge parallel to the center of the valley. Metal valley flashing with a W-crease should be used.

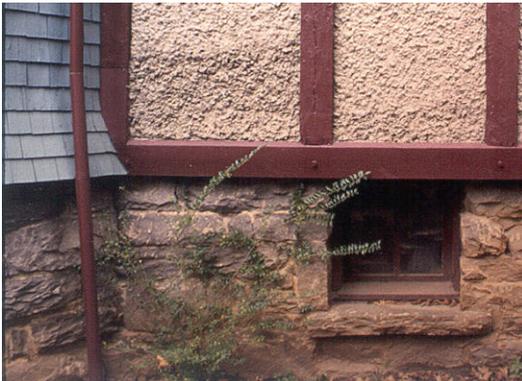
Below: The stone foundation of Clover Cottage.

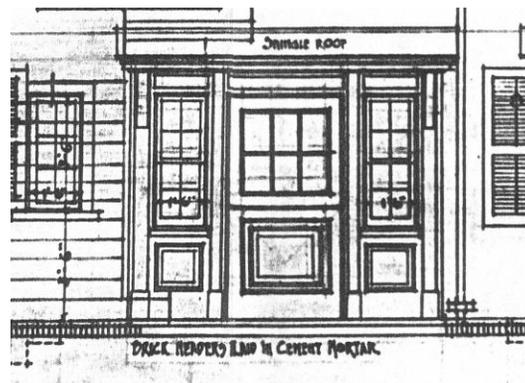
Below: In a few instances, original blueprints exist, which are wonderfully helpful in guiding repairs and restorations. This detail is from the plans for Foxhall Cottage, designed by J. Neel Reid, a prominent Atlanta architect.

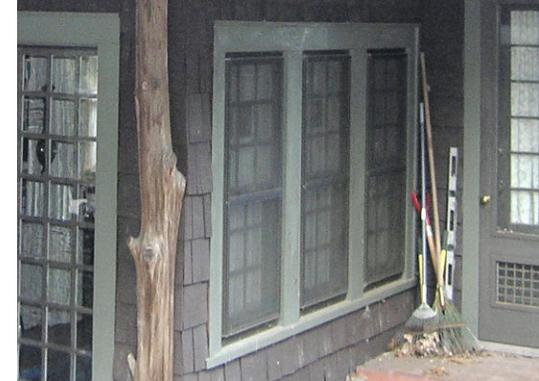
Above: The exterior storms on these windows are full-screen, painted the same color as the windows sashes, with the cross-brace at the same height as the meeting rail of the two window sashes.
