Architectural Design Standards & Guidelines

Albemarle Park Local Historic District • Asheville, North Carolina

Produced by the Historic Resources Commission
of Asheville & Buncombe County
in association with
The Albemarle Park ~ Manor Grounds Association, Inc.

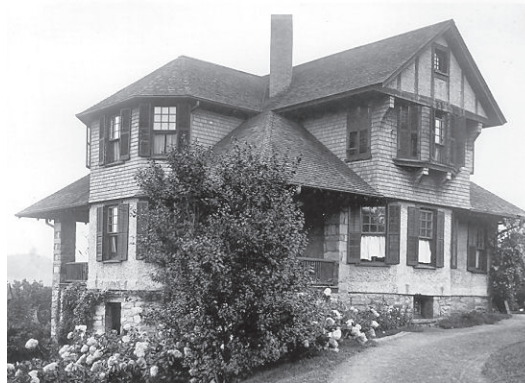
Clematis Cottage possesses many of the design features of this style - half-timbering in the gables, shingles at the 2nd floor; pebbledash stucco at the 1st floor, and a stone foundation.

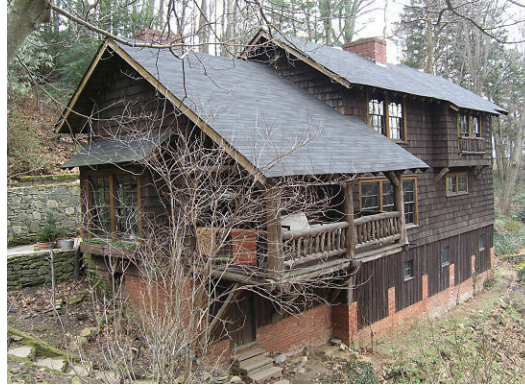
Above: Possum Trot, displaying several of the key elements of the Rustic Shingle Style - dark brown stained shingles, large timbers used for porch supports, and projecting bay windows.

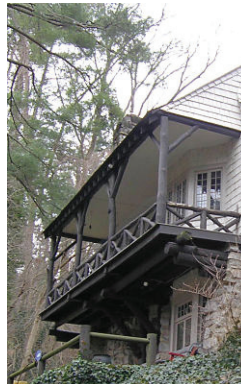
Below left: Porch at Crow's Nest, made from large timbers stripped of their bark.

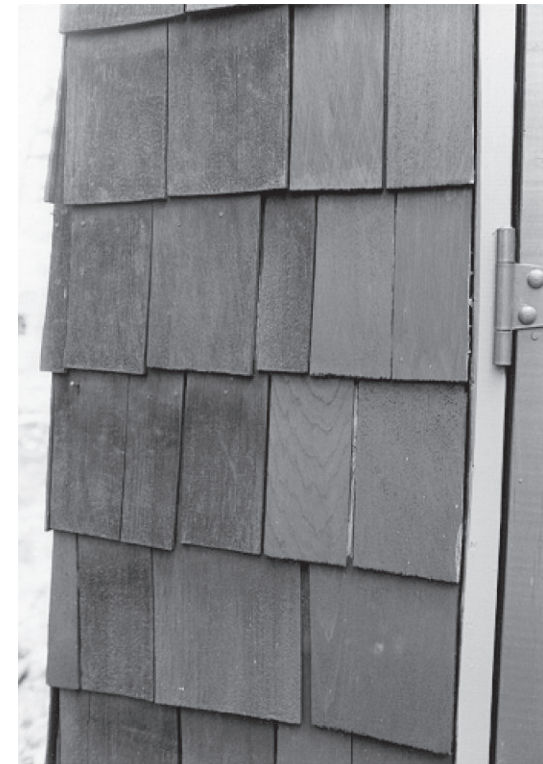
Above: Doing repairs to historic houses requires a nuanced and respectful approach. Replacement shingles on this garage stand out because their texture doesn't match the original. A better approach would have been to use new shingles for the entire rows, possible replacing a much larger section than necessary to mute the visible contrast.

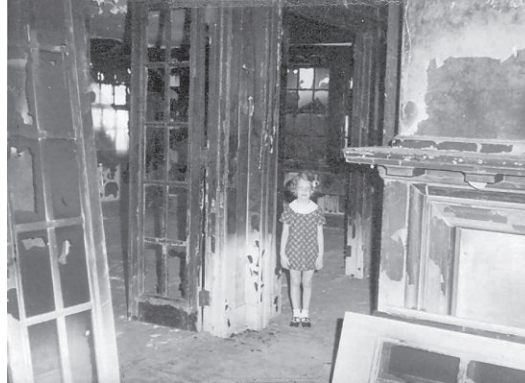
Above: The result of a terrible fire which did extensive damage to Fox Hall cottage in the 1960s.

For thirty years or longer, Fox Hall was sheathed in pink cement shingles and thin veneer brick. The cottage had suffered a severe fire and these were the materials selected when it was repaired and renovated.

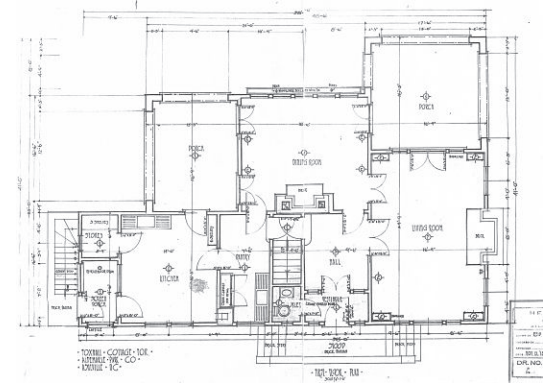
Above: The first floor plan from the blueprints that were at Georgia Tech.

Then, a phone call out of the blue from a historian in Raleigh led to the discovery of the original blueprints for the cottage. It was designed by J. Neel Reid, a prominent Georgia architect, and the firm Hentz & Reid.

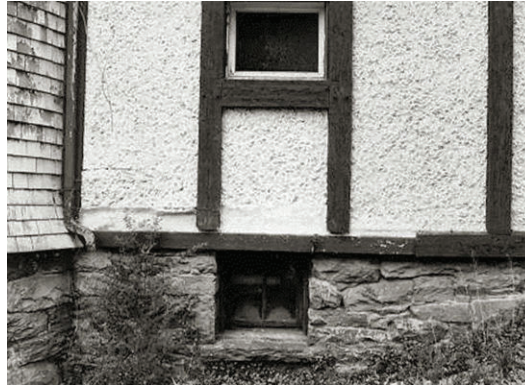
Above: Instead of repairing deteriorated stucco with fresh pebbledash/roughcast stucco, wood lap siding was used.

Below: The lap siding was removed and the half-timbering and stucco were repaired to restore the original appearance.

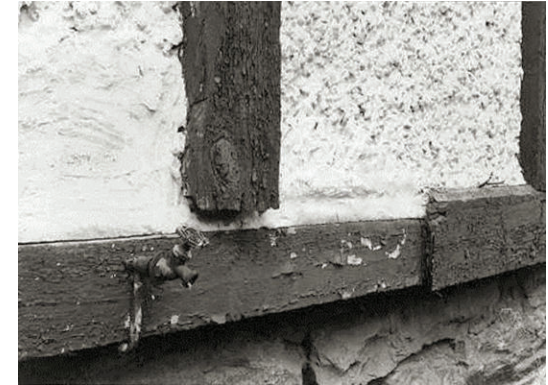
Above: Deteriorated pebbledash/roughcast stucco and a rotten band board were replaced by inappropriate materials - smooth plaster and an undersized board.

Below: The inappropriate repairs were removed. Stucco which matches the original was applied and a band board milled and beveled to match the existing was installed.

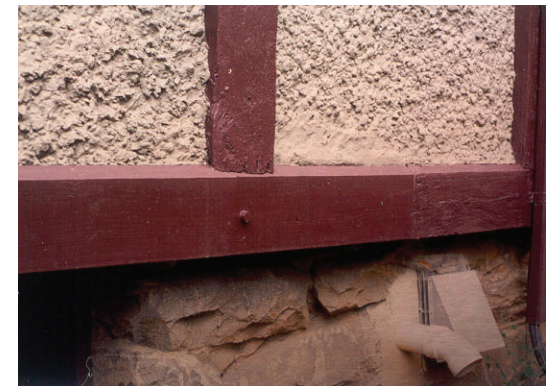
Below: Close up photo of the new stucco and band board, applied with care, to restore the original appearance of the wall.

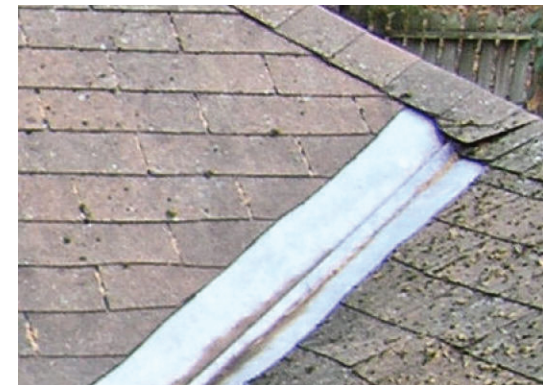
Below: Valleys should be open, with shingles trimmed to a straight edge parallel to the center of the valley. Metal valley flashing with a W-crease should be used.

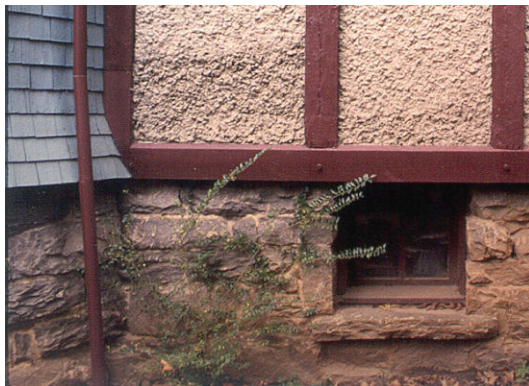
Below: The stone foundation of Clover Cottage.

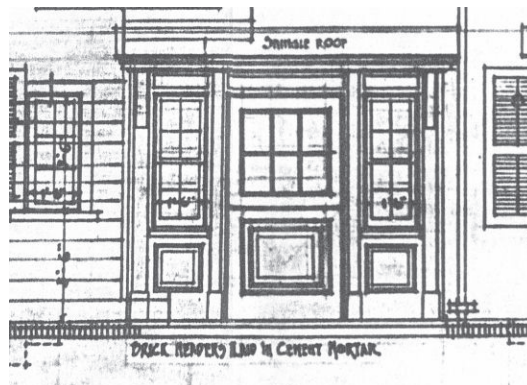
Below: In a few instances, original blueprints exist, which are wonderfully helpful in guiding repairs and restorations. This detail is from the plans for Foxhall Cottage, designed by J. Neel Reid, a prominent Atlanta architect.

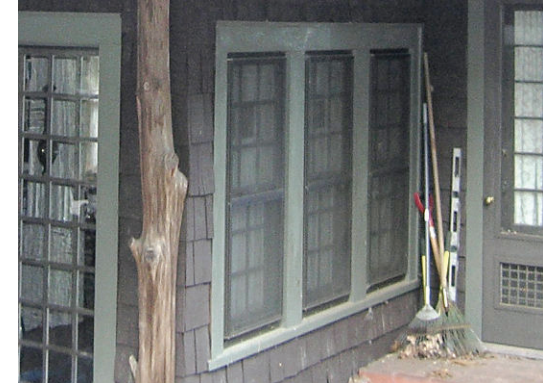
Above: The exterior storms on these windows are full-screen, painted the same color as the windows sashes, with the cross-brace at the same height as the meeting rail of the two window sashes.
